**MANAGEMENT OF A PERISHED IMPLANT USING CUSTOM TITANIUM POST
AND CORE SUPPORTED SPLINTED PROSTHESIS WITH 3 YEARS FOLLOW UP:
A RARE CASE REPORT**

This article focuses on a new method for rescuing an implant with a fractured abutment screw. This technique involves using a custom titanium post and core-supported splinted prosthesis.

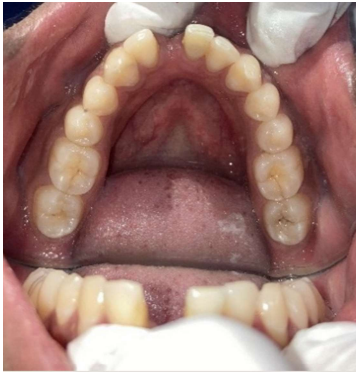
A male patient aged 22 years visited the Department of Prosthodontics, Subharti Dental College, Meerut, complaining about missing teeth in the mandibular anterior tooth region. He had previously undergone root canal treatment in the same area. An intra-oral examination revealed an edentulous area about tooth 41 and root canal-treated teeth in relation to 31, without any prosthesis (Figure 1).

Figure 1. Intraoral photograph showing missing 41 and root canal treated 31

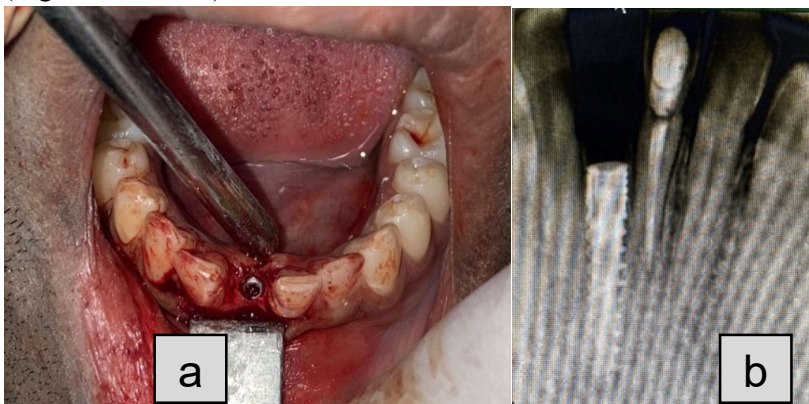
Accordingly, a narrow diameter implant of size 2.9mm X 13mm (Bioline) was placed under local anesthesia, and the surgical site was closed using sutures after tightening a cover screw (Figures 3a and b).

Figure 3 (a and b). Clinical and radiographic images showing the placed implant. After 15 days, the patient was recalled for follow-up. The implant had successfully osseointegrated after 3 months. During the final torquing of the abutment screw on the day of prosthesis cementation, the screw fractured at the apical third of the abutment channel (Figure 4) but attempts to retrieve it using an ultrasonic scaler tip failed.

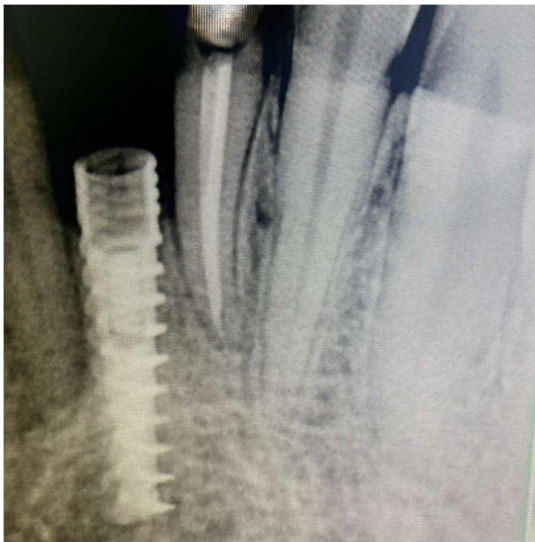
Figure 4. Radiographic image showing fractured abutment screw

The patient was unwilling to undergo implant removal to avoid catastrophe and placement of a new implant, so it was decided to use the screw hole as a channel for a custom-fabricated nickel-chromium post and core, followed by fabrication of a metal-free crown and splinting it with the adjacent root canal-treated tooth which was very firm (tooth 31). To eliminate the internal threads of the implant, a tungsten carbide bur at low speed using an electric handpiece was used. Custom posts were made using pattern resin and endodontic files. Once retention was achieved, the core build was done using pattern resin and was prepared extra-orally to avoid any detrimental force on the underlying implant (Figure 5a and b).

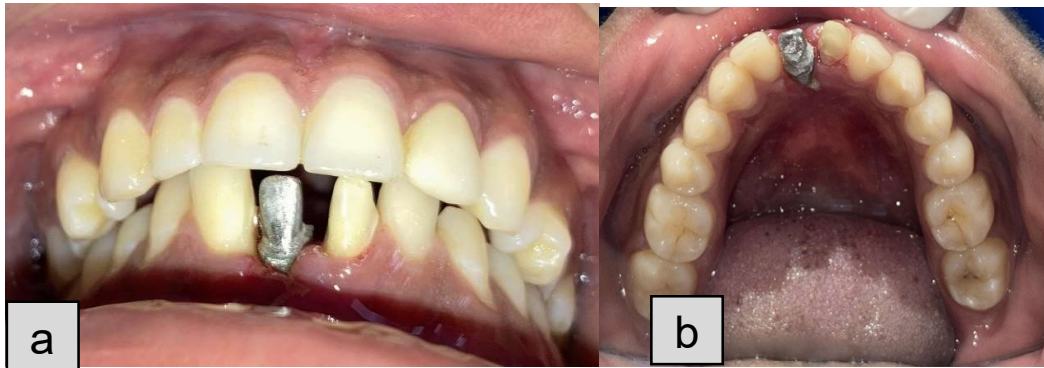
Figure 6 (a and b). Intraoral photograph showing luted nickel-chromium cast post and core

The pattern was then cast in nickel-chromium alloy and verified intraorally before luting with variolink cement (Figures 6a and b).

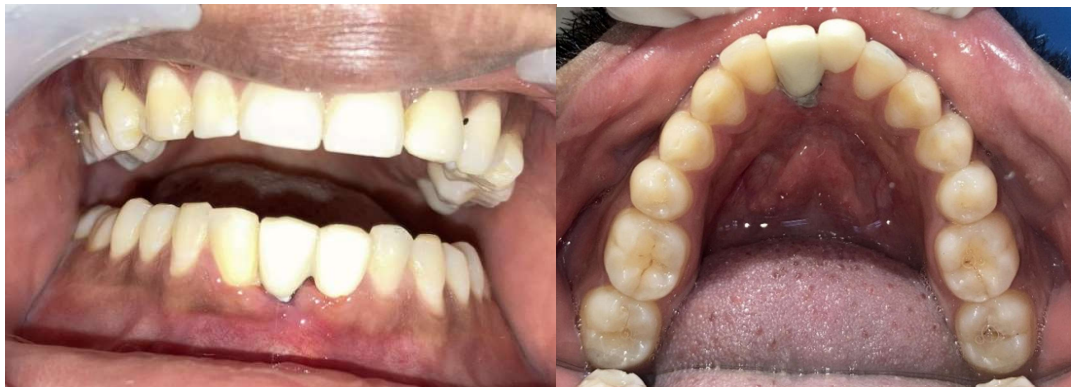
Figure 7(a and b) Intraoral photograph showing final cemented prosthesis in relation to 31 and 41

Tooth preparation of the adjacent root canal-treated tooth was done and the final impression was made using polyvinyl siloxane impression material, and two splinted metal-free crowns were fabricated and tried for fit, with occlusion adjusted intraorally. All the interferences in protrusive and lateral excursive movements were eliminated (Figures 7a and 7b).

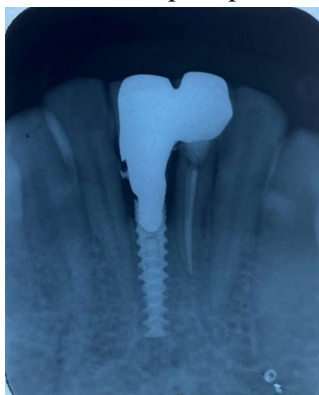
An intra-oral periapical radiograph confirmed the fit of the final prosthesis (figure 8).

Figure 8 Intraoral periapical radiograph showing cemented final prosthesis

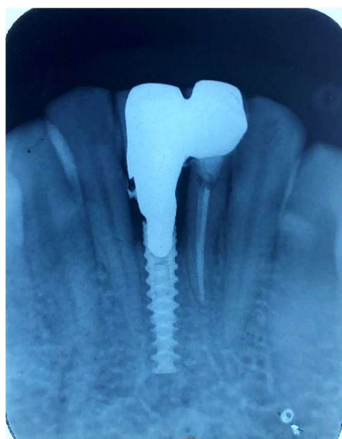
The patient was scheduled for routine check-ups for a period of three years, during which no issues were detected regarding function or appearance (Figure 9).

Figure 9 Intraoral periapical radiograph after 3 years of follow up
